Project: FY2023-FY2025 Facade Restoration at Guaranteed Rate Field

Client: Illlinois Sports Facilities Authority

Engineer: Wiss, Janney, Elstner Associates, Inc.

Title Sheet

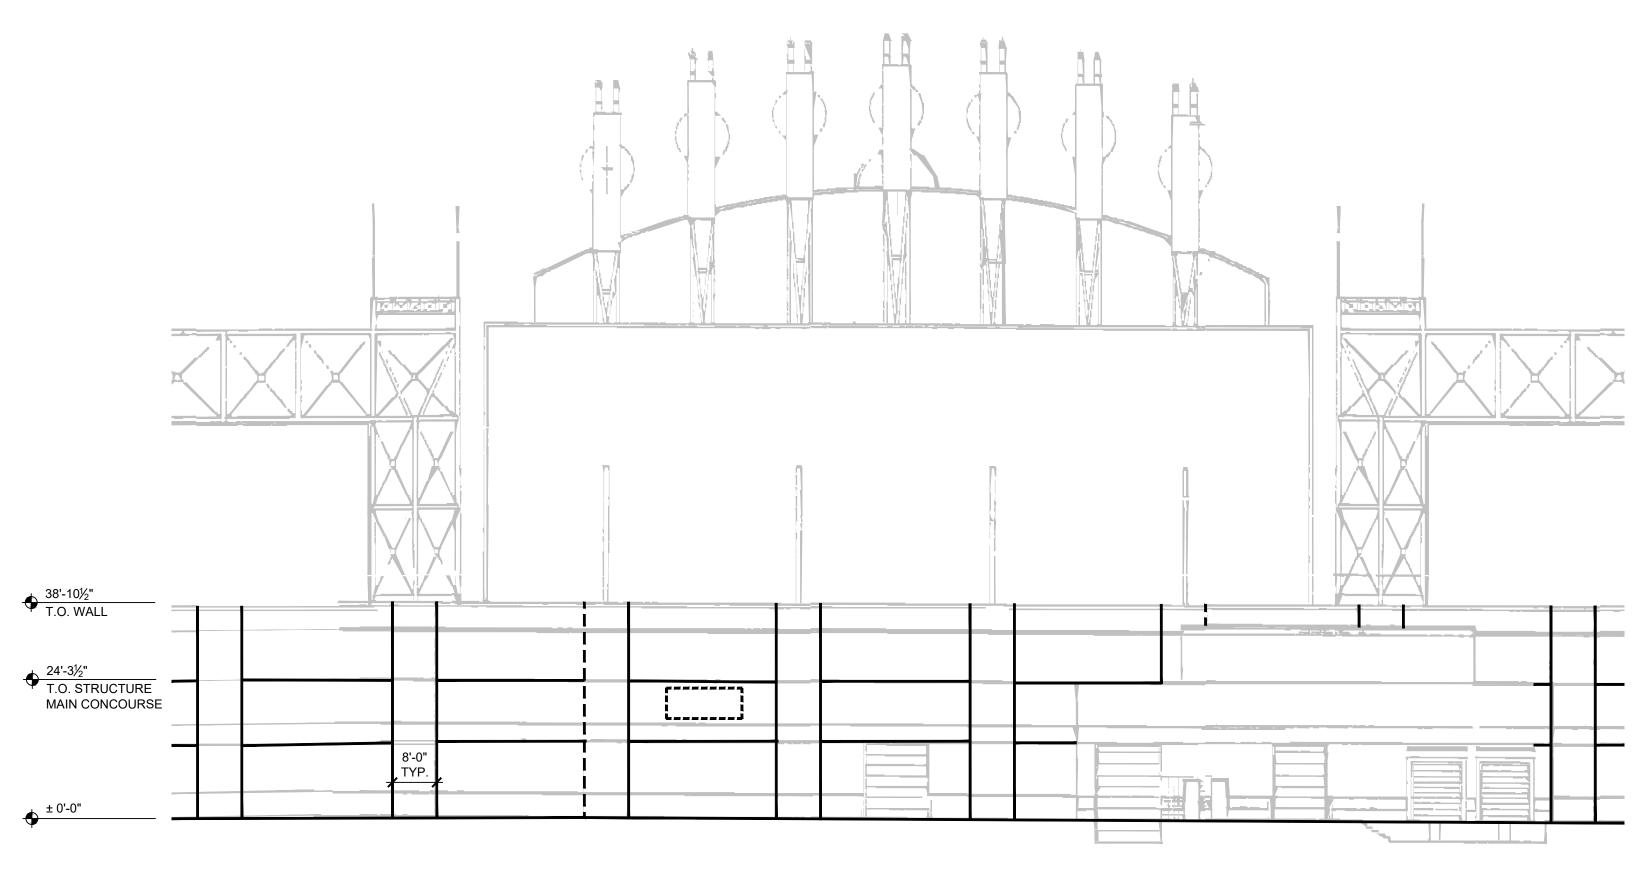
PARTIAL FACADE ELEVATION (COLUMN LINES 57 TO 4) NOT TO SCALE

ARCHITECTURAL PRECAST PANEL SPALL (SEE REPAIR DETAIL 1/S-502)

CMU (SEE REPAIR DETAIL 5/S-503)

INDICATES PRECAST TO PRECAST SEALANT JOINT TO BE REMOVED AND REPLACED. SEE SHEET S-502 FOR ADDITIONAL INFORMATION.

INDICATES EXPANSION JOINT TO BE REMOVED AND REPLACED. SEE SHEET S-502 FOR ADDITIONAL INFORMATION.

INDICATES PRECAST TO WINDOW / LOUVER SEALANT JOINT TO BE REMOVED AND REPLACED. SEE SHEET S-502 FOR ADDITIONAL INFORMATION.

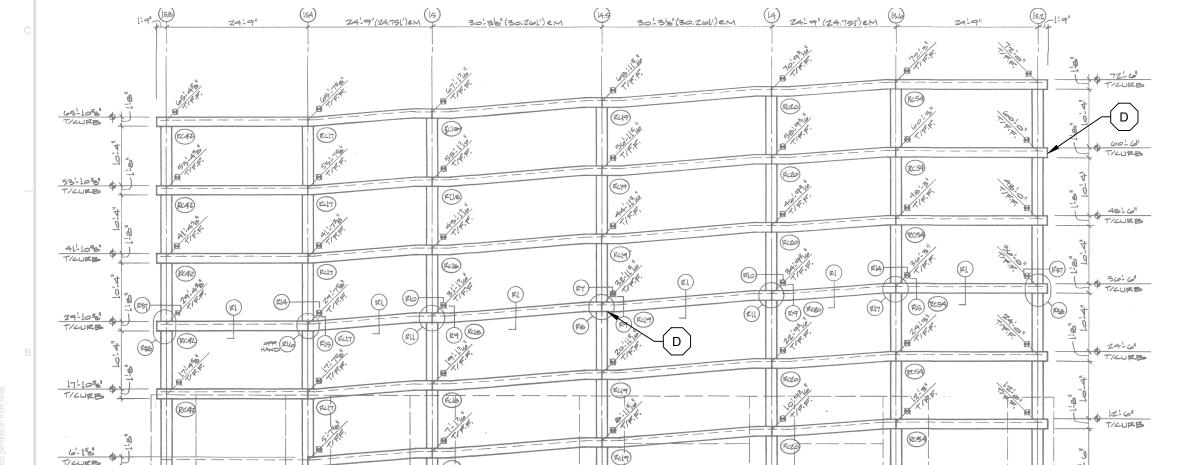
RAMP 1 - SOUTHWEST ELEVATION

- SPANDREL SPALL AT EMBEDDED CONNECTION (SEE REPAIR DETAIL 1/S-501)
- SPALLLED OR DELAMINATED MORTAR PATCH (SEE REPAIR DETAIL 2/S-501)
- SPANDREL SPALL AT RAILING EMBED (SEE REPAIR DETAIL 3/S-501)
- BEAM END SPALL AT EXPOSED PRESTRESSING STRANDS (SEE REPAIR DETAIL 4/S-501)
- CRACKED WELD AT PRECAST WALL PANEL CONNECTION (SEE REPAIR DETAIL 5/S-501)
- CLEAN AND PAINT EXPOSED CONNECTION ADJACENT TO COLUMN SPALL (SEE REPAIR DETAIL 6/S-501)
- SPANDREL END SPALL AT EXPOSED PRESTRESSING STRANDS (SEE REPAIR DETAIL 6/S-503)
- ARCHITECTURAL PRECAST PANEL SPALL (SEE REPAIR DETAIL 1/S-502)

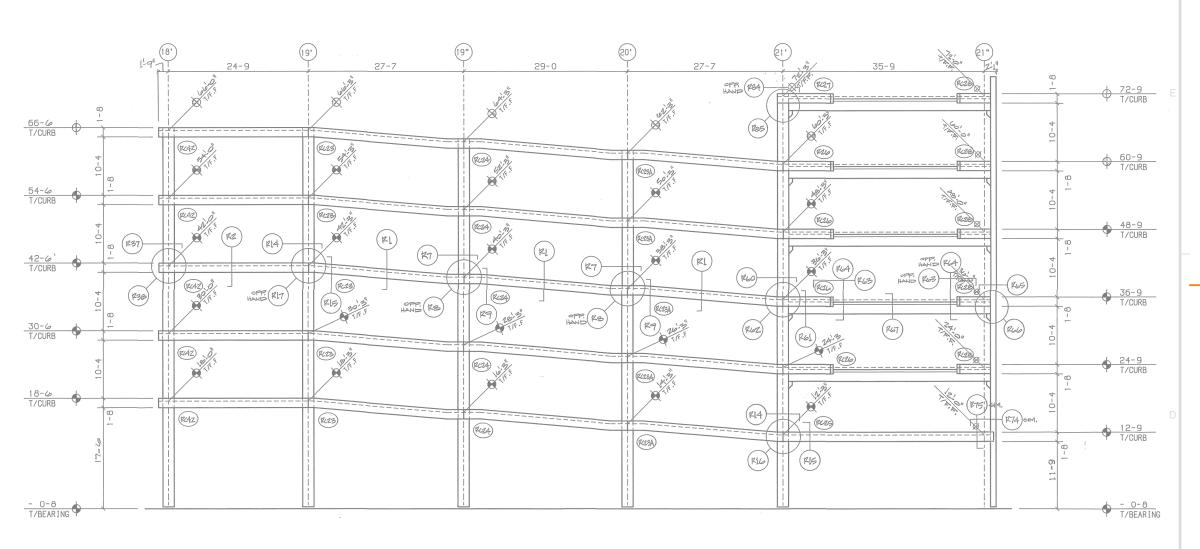
RAMP 2 - NORTH ELEVATION

- A SPANDREL SPALL AT EMBEDDED CONNECTION (SEE REPAIR DETAIL 1/S-501)
- B SPALLLED OR DELAMINATED MORTAR PATCH (SEE REPAIR DETAIL 2/S-501)
- C SPANDREL SPALL AT RAILING EMBED (SEE REPAIR DETAIL 3/S-501)
- D BEAM END SPALL AT EXPOSED PRESTRESSING STRANDS (SEE REPAIR DETAIL 4/S-501)
- E CRACKED WELD AT PRECAST WALL PANEL CONNECTION (SEE REPAIR DETAIL 5/S-501)
- CLEAN AND PAINT EXPOSED CONNECTION ADJACENT TO COLUMN SPALL (SEE REPAIR DETAIL 6/S-501)
- G SPANDREL END SPALL AT EXPOSED PRESTRESSING STRANDS (SEE REPAIR DETAIL 6/S-503)
- ARCHITECTURAL PRECAST PANEL SPALL (SEE REPAIR DETAIL 1/S-502)

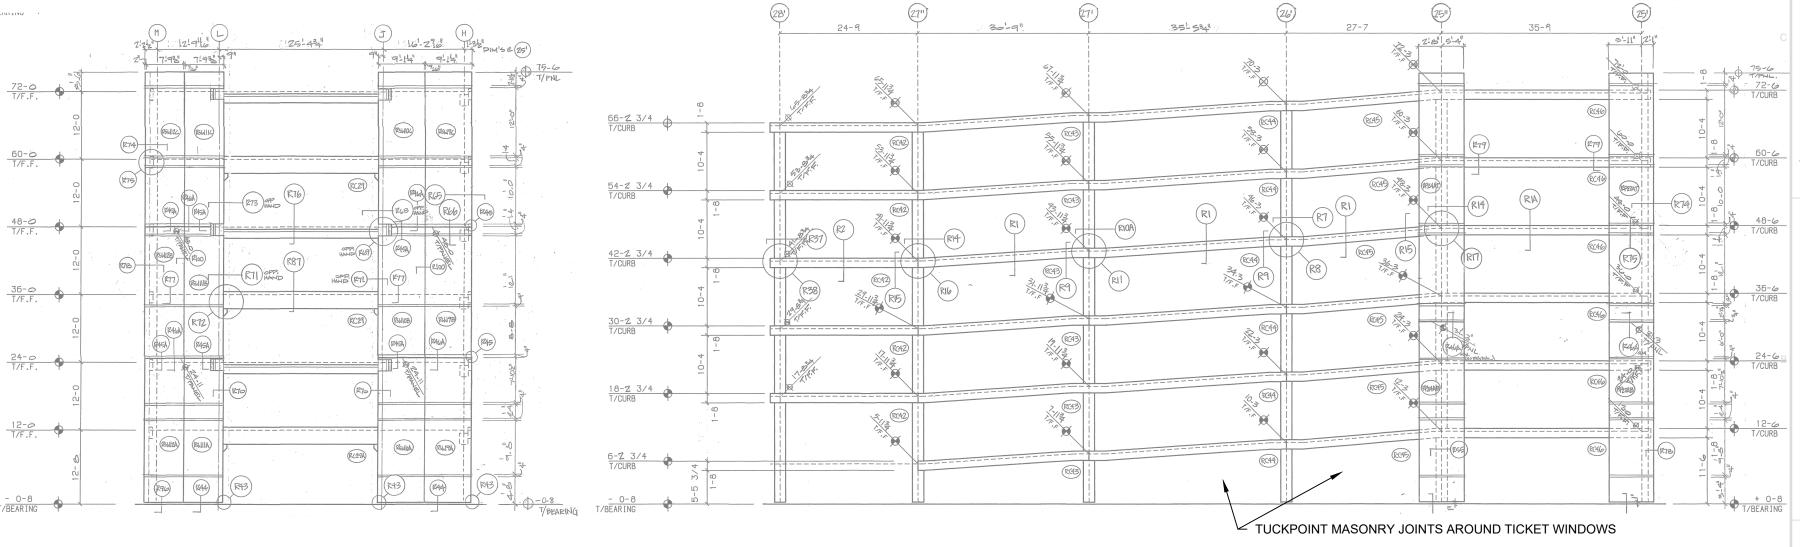
RAMP 3 - SOUTH ELEVATION
NOT TO SCALE

- A SPANDREL SPALL AT EMBEDDED CONNECTION (SEE REPAIR DETAIL 1/S-501)
- B SPALLLED OR DELAMINATED MORTAR PATCH (SEE REPAIR DETAIL 2/S-501)
- C SPANDREL SPALL AT RAILING EMBED (SEE REPAIR DETAIL 3/S-501)
- D BEAM END SPALL AT EXPOSED PRESTRESSING STRANDS (SEE REPAIR DETAIL 4/S-501)
- E CRACKED WELD AT PRECAST WALL PANEL CONNECTION (SEE REPAIR DETAIL 5/S-501)
- CLEAN AND PAINT EXPOSED CONNECTION ADJACENT TO COLUMN SPALL (SEE REPAIR DETAIL 6/S-501)
- G SPANDREL END SPALL AT EXPOSED PRESTRESSING STRANDS (SEE REPAIR DETAIL 6/S-503)
- ARCHITECTURAL PRECAST PANEL SPALL (SEE REPAIR DETAIL 1/S-502)

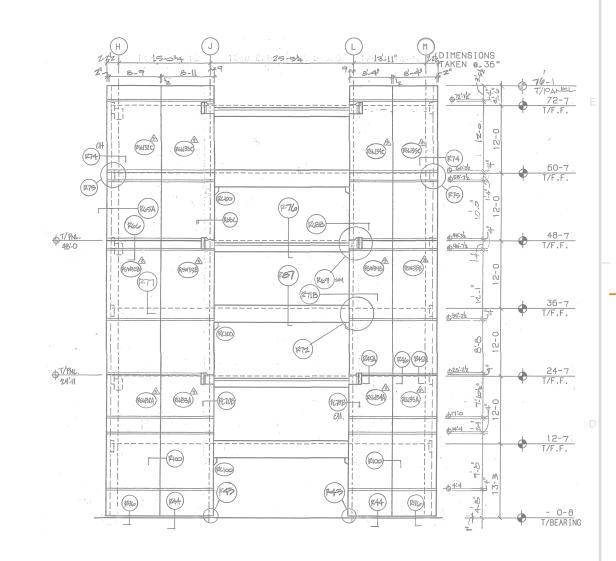
RAMP 4 - EAST ELEVATION

CRACKED WELD AT RAILING BASE PLATE. RE-WELD ALL AROUND WITH %" FILLET WELD. A QUIZA 55-9 T/CURB 43-9 T/CURB 31-9 T/CURB (P.95) 1. 1/4. 25-22 25-4 T/CURB - 0-8 T/BEARING

- SPANDREL SPALL AT EMBEDDED CONNECTION (SEE REPAIR DETAIL 1/S-501)
- SPALLLED OR DELAMINATED MORTAR PATCH (SEE REPAIR DETAIL 2/S-501)
- SPANDREL SPALL AT RAILING EMBED (SEE REPAIR DETAIL 3/S-501)
- BEAM END SPALL AT EXPOSED PRESTRESSING
- CRACKED WELD AT PRECAST WALL PANEL CONNECTION (SEE REPAIR DETAIL 5/S-501)
- TO COLUMN SPALL (SEE REPAIR DETAIL 6/S-501)
- SPANDREL END SPALL AT EXPOSED PRESTRESSING STRANDS (SEE REPAIR DETAIL 6/S-503)
- ARCHITECTURAL PRECAST PANEL SPALL (SEE REPAIR DETAIL 1/S-502)

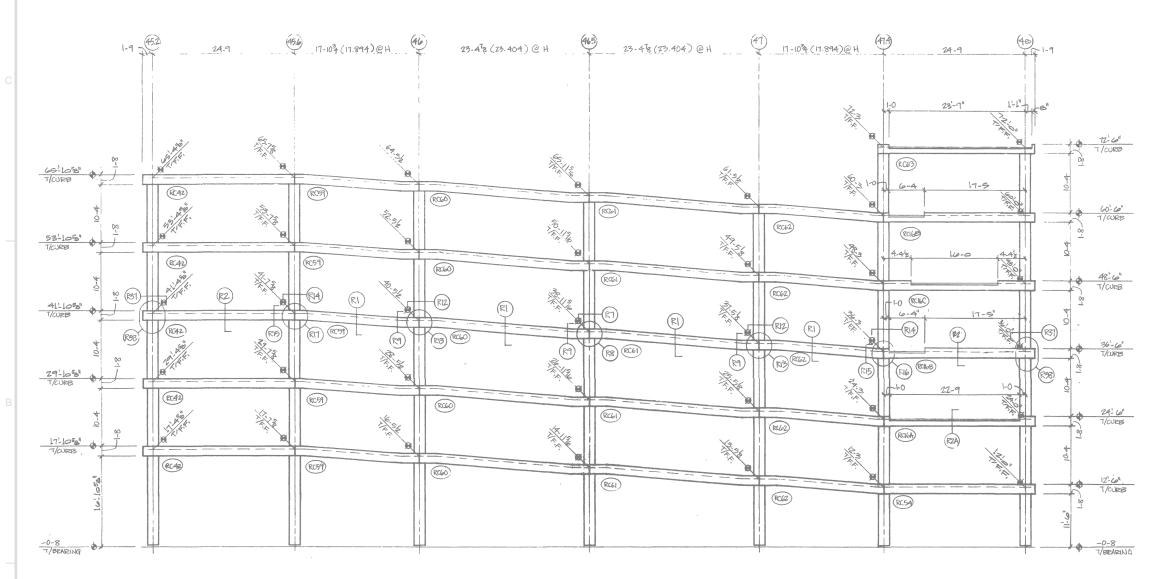
RAMP 6 - NORTHWEST ELEVATION RAMP 6 - SOUTHWEST ELEVATION

SHORE HOLLOW CORE PLANKS AND SPANDREL BEAMS TO FACILITATE CORBEL REPAIRS 75-6 T/PANEL 9 72-0 m 60-0 T/F.F. 48-0 T/F.F. REPAIR CORBEL, REFER TO DETAILS 3 AND 4/S-503 12-0 T/E.F.

+ 6-0 6-0 68-1058 T/PANEL 65-458 T/F.F. 53.48 T/F.F 41-4⁵8 7/F.F. 29-43 T/F.F. 5-4% T/F.F.

- SPANDREL SPALL AT EMBEDDED CONNECTION (SEE REPAIR DETAIL 1/S-501)
- SPALLLED OR DELAMINATED MORTAR PATCH (SEE REPAIR DETAIL 2/S-501)
- SPANDREL SPALL AT RAILING EMBED (SEE REPAIR DETAIL 3/S-501)
- BEAM END SPALL AT EXPOSED PRESTRESSING STRANDS (SEE REPAIR DETAIL 4/S-501)
- CRACKED WELD AT PRECAST WALL PANEL CONNECTION (SEE REPAIR DETAIL 5/S-501)
- CLEAN AND PAINT EXPOSED CONNECTION ADJACENT TO COLUMN SPALL (SEE REPAIR DETAIL 6/S-501)
- SPANDREL END SPALL AT EXPOSED PRESTRESSING STRANDS (SEE REPAIR DETAIL 6/S-503)
- ARCHITECTURAL PRECAST PANEL SPALL (SEE REPAIR DETAIL 1/S-502)

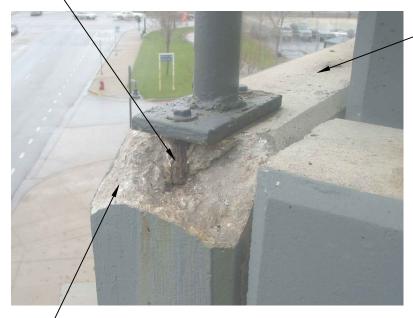
CONCRETE REPAIR AT EMBEDDED CONNECTION

EXISTING SAWCUT EDGE REINFORCING STEEL AROUND PERIMETER AND CONNECTION PLATES. SANDLBAST **CLEAN AND PAINT** WITH EPOXY. **EXISTING 6" WIDE** CONCRETE SPANDREL BEAM REMOVE ALL UNSOUND CONCRETE. 3/4" MIN. CLEARANCE REPAIR WILL TYPICALLY EXTEND 6" TO BEHIND EXISTING REINFORCING 12" ALONG SPANDREL. RECAST TO PROFILE SHOWN. PAINT SURFACE TO MATCH EXISTING WHERE APPLICABLE.

GRIND 45 DEGREE, SMOOTH, BEVELED EDGE ON EXISTING CONCRETE TO REMAIN AROUND PERIMETER CLEAN AND PAINT SURFACE OF **EXPOSED CONNECTION PLATES** REMOVE SPALLED AND DELAMINATED CLEAN AND PAINT SURFACE OF

EXISTING ANCHOR BOLT AND REINFORCING STEEL. SANDBLAST CLEAN AND PAINT WITH EPOXY. REPLACE ALL ANCHOR BOLTS WITH SIGNIFICANT CORROSION.

- REMOVE CONCRETE AS REQUIRED TO OBTAIN A MINIMUM 3/4" CLEARANCE BEHIND EXISTING REINFORCING OR ANCHORS.
- 2. INSTALL EPOXIED IN STAINLESS STEEL ANCHORS AS DIRECTED BY THE ENGINEER. STAINLESS STEEL ANCHORS SHALL NOT BE IN DIRECT CONTACT WITH REINFORCING STEEL BARS OR ANCHOR BOLT.

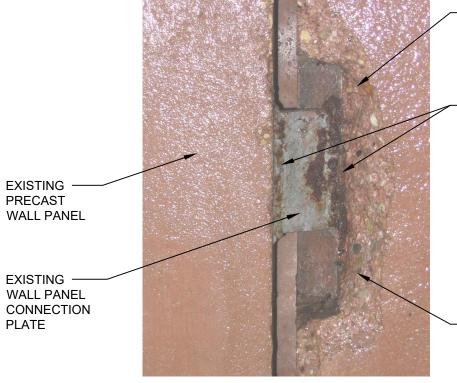
SPALLED MORTAR PATCH REPAIR

REMOVE ALL UNSOUND CONCRETE. REPAIR WILL TYPICALLY EXTEND 6" TO 12" ALONG SPANDREL. RECAST CONCRETE REPAIR TO MATCH ORIGINAL PROFILE. PAINT SURFACE TO MATCH EXISTING WHERE APPLICABLE.

GRIND 45 DEGREE, SMOOTH, BEVELED EDGE ON EXISTING CONCRETE TO REMAIN AROUND PERIMETER

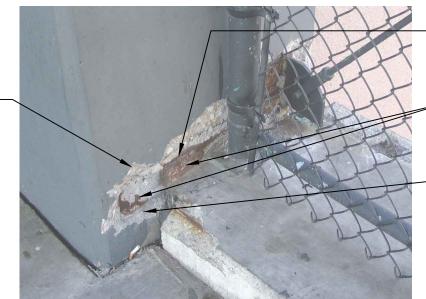
COLUMN SPALL REPAIR ADJACENT TO EMBEDDED CONNECTION PLATES

INSTALL CANT BEAD OF SILICONE SEALANT AROUND PERIMETER OF EACH STEEL PLATE

SANDBLAST CLEAN AND PAINT ALL EXPOSED

REMOVE ALL SPALLED CONCRETE ADJACENT TO EMBEDDED CONNECTION PLATES. NOTIFY ENGINEER IF UNSOUND CONCRETE EXTENDS BEHIND CONNECTION PLATES. CONCRETE REPAIRS MAY BE NECESSARY AT SOME LOCATIONS.

- e. REMOVE SCALED AND LOOSE CONCRETE, AND CLEAN AND PAINT EXISTING CONNECTION PLATES ON COLUMN FACES.
 - f. REPAIR SPALLED OR DELAMINATED CONCRETE ON VERTICAL SURFACES OF COLUMNS OR BEAMS.

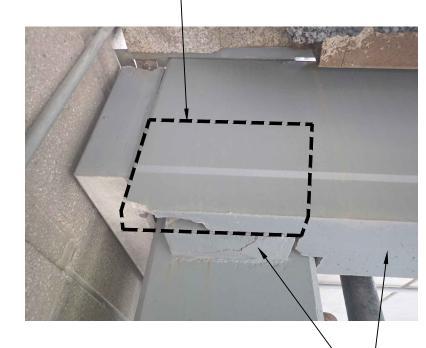
CORBEL REPAIR DETAIL - PLAN

EXISTING SPANDREL BEAM TO REMAIN. SHORE -SPANDREL BEAM AND IN-FRAMING HOLLOWCORE SLABS PRIOR TO PERFORMING CORBEL REPAIRS. CREATE OPENING IN EXISTING SPANDREL BEAM END TO EXPOSE CONCEALED CORBEL SUPPORT. INSTALL SHORING PRIOR TO CREATING OPENING. FOLLOWING COMPLETION OF CORBEL REPAIRS, RECAST SPANDREL AREA AND PAINT TO MATCH EXISTING. **EXISTING COLUMN TO REMAIN** EXISTING CONCRETE ENCASED STEEL CORBEL AND ANCHOR PLATE ON COLUMN. REMOVE ALL CONCRETE ENCASEMENT TO FULLY EXPOSE ANCHOR PLATE, TUBE SECTION, REINFORCING STEEL AND BEARING PLATE. ABRASIVE BLAST AND COAT ALL STEEL SURFACES WITH TWO COATS OF TNEMEC SERIES 135. REPLACE STEEL BEARING PLATE WITH NEW HOT DIP GALVANIZED 4 S-503 PLATE. RECAST CONCRETE CORBEL TO MATCH EXISTING. INSTALL SHORING FOR SPANDREL AND HOLLOWCORE SLABS PRIOR TO PERFORMING REPAIRS. REFER TO DETAIL 4/S-503. **EXISTING COLUMN** CREATE OPENING IN EXISTING SPANDREL BEAM END TO EXPOSE CONCEALED CORBEL SUPPORT. INSTALL SHORING PRIOR TO CREATING OPENING. FOLLOWING COMPLETION OF CORBEL REPAIRS, RECAST SPANDREL AREA AND PAINT TO MATCH EXISTING.

EXISTING CONCRETE ENCASED STEEL CORBEL TO BE REPAIRED, REFER TO DETAIL 4/S-503

EXISTING SPANDREL BEAM TO REMAIN. SHORE SPANDREL BEAM AND IN-FRAMING HOLLOWCORE SLABS PRIOR TO PERFORMING CORBEL REPAIRS.

- g. REPAIR EXISTING CORBELS WHERE NOTED ON RAMP 6. INSTALL SHORING.
- CLEAN AND PAINT EXPOSED REINFORCING STEEL BAR ENDS ON EXTERIOR FACADE OF THE BALLPARK AT LOCATIONS WHERE THE SURROUNDING CONCRETE IS SOUND. PAINTED FINISH SHALL MATCH SURROUNDING COLOR OF PRECAST CONCRETE.

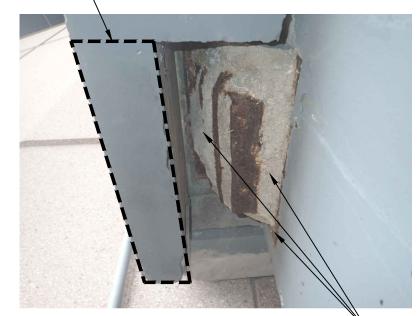
> **CORBEL REPAIR DETAIL -UNDERSIDE VIEW**

CREATE OPENING IN EXISTING SPANDREL BEAM END TO EXPOSE CONCEALED CORBEL SUPPORT. INSTALL SHORING PRIOR TO CREATING OPENING. FOLLOWING COMPLETION OF CORBEL REPAIRS, RECAST SPANDREL AREA AND PAINT TO MATCH EXISTING.

EXISTING CONCRETE ENCASED STEEL CORBEL AND ANCHOR PLATE ON COLUMN. REMOVE ALL CONCRETE ENCASEMENT TO FULLY EXPOSE ANCHOR PLATE, TUBE SECTION, REINFORCING STEEL AND BEARING PLATE. ABRASIVE BLAST AND COAT ALL STEEL SURFACES WITH TWO COATS OF TNEMEC SERIES 135. REPLACE STEEL BEARING PLATE WITH NEW HOT DIP GALVANIZED PLATE. RECAST CONCRETE CORBEL TO MATCH EXISTING. INSTALL SHORING FOR SPANDREL AND HOLLOWCORE SLABS PRIOR TO PERFORMING REPAIRS.

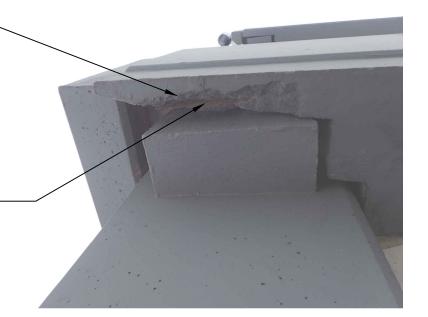
SPANDREL END SPALL DETAIL AT EXPOSED PRESTRESSING STRANDS

REMOVE ALL UNSOUND CONCRETE. STOP WORK AND NOTIFY ENGINEER IF CONCRETE REMOVAL AND STRAND CORROSION EXTEND BEYOND CORBEL

EXISTING PRESTRESSING STEEL. SANDBLAST CLEAN AND PAINT WITH EPOXY.

- 1. REMOVE CONCRETE AS REQUIRED TO OBTAIN A MINIMUM 3/4" CLEARANCE BEHIND EXISTING REINFORCING STEEL.
- 2. INSTALL EPOXIED-IN STAINLESS STEEL ANCHORS AS DIRECTED BY THE ENGINEER. STAINLESS STEEL ANCHORS SHALL NOT BE IN DIRECT CONTACT WITH REINFORCING STEEL BARS.
- 3. PAINT CONCRETE TO MATCH EXISTING FOLLOWING COMPLETION OF REPAIR.
